FLOOR MOSAICS FROM THE GRECO-ROMAN THEATRE AT NEA PAPHOS

JENNIE LINDBERGH

THE NEA PAPHOS THEATRE MOSAIC FLOORS

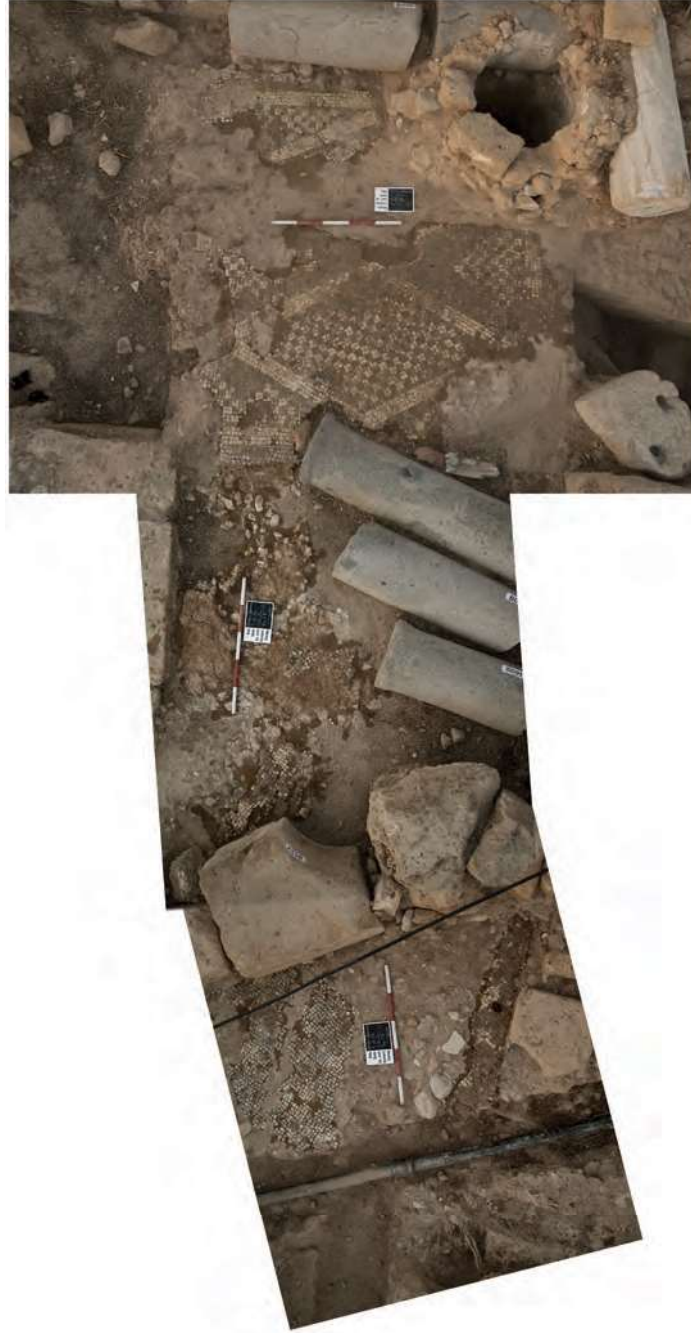
Fig. 2. The fragmentary mosaic on the floor of the eastern *parodos* and its southern entry. The damage caused by later activities is clearly demonstrated (photo: Bob Miller, 10 November 2010)

odos, and a possible room to the west of the southern entry to the western *parodos* (Fig. 1). The mosaics likely represent two phases in the life of the theatre. The floor of the eastern *parodos* and its southern entry is covered in a fragmentary black/grey and white geometric mosaic, the largest extent of which is within the *parodos* and comprises large white lozenges with infill chequerboard on a black ground (Fig. 2). The mosaic floor of the nymphaeum is in a poor condition with evidence of efflorescence, delamination and a loss of integrity in the cement setting, likely due to the use of limestone for the white tesserae relieved

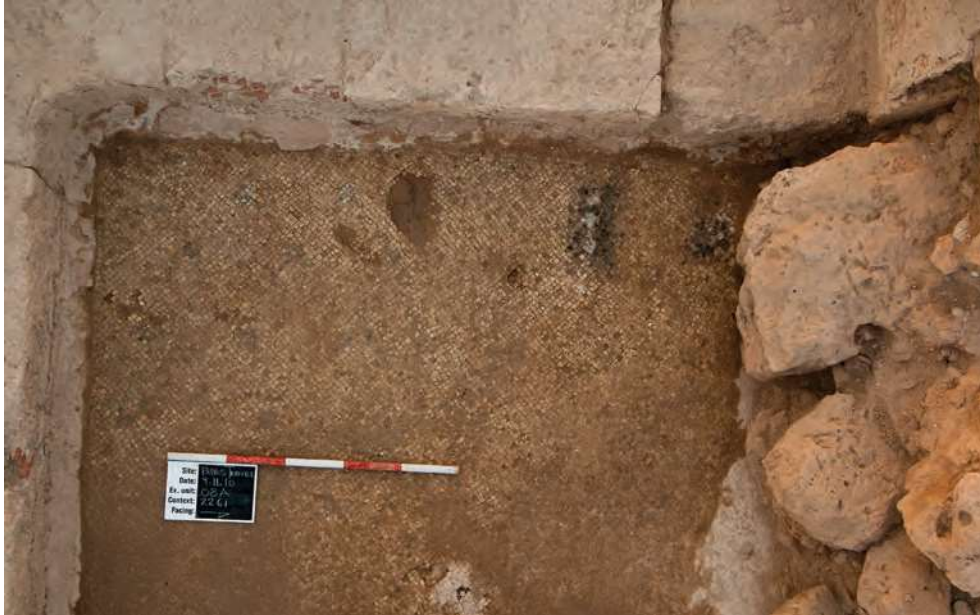
Fig. 3. South-west corner of the poorly preserved nymphaeum floor mosaic. Edges are chamfered and there are patches of burning (photo: Bob Miller, 10 November 2010)

by a scatter of small black semis (Fig. 3). The floor of the western *parodos* is surfaced in a hard fine white plaster, scored to imitate large pavers, possibly marble. The plastered floor extends to the threshold to the southern entry where it meets the remains of what had been an expanse of predominantly black tesserae, the only discernible pattern being one white on black crosslet. These mosaics and those in the western *parodos* and nymphaeum have been dated to the Antonine refurbishment of the theatre in the mid-second century. The simplicity of design and lack of colour in the mosaics associated with the *parodoi* was likely offset by the colourful paintings decorating the vaulted walls and ceilings, for which extensive evidence survives from the western *parodos* (Wood Conroy 2003). Dating to the late fourth or early fifth century is a polychrome geometric mosaic on the floor of what may be a small room or corridor to the west of the western *parodos* southern entry (Fig. 4). Too little of the immediate environment of this mosaic has been excavated to be certain of a room function, or its ultimate size. However, this mosaic likely dates to after the abandonment of the theatre.

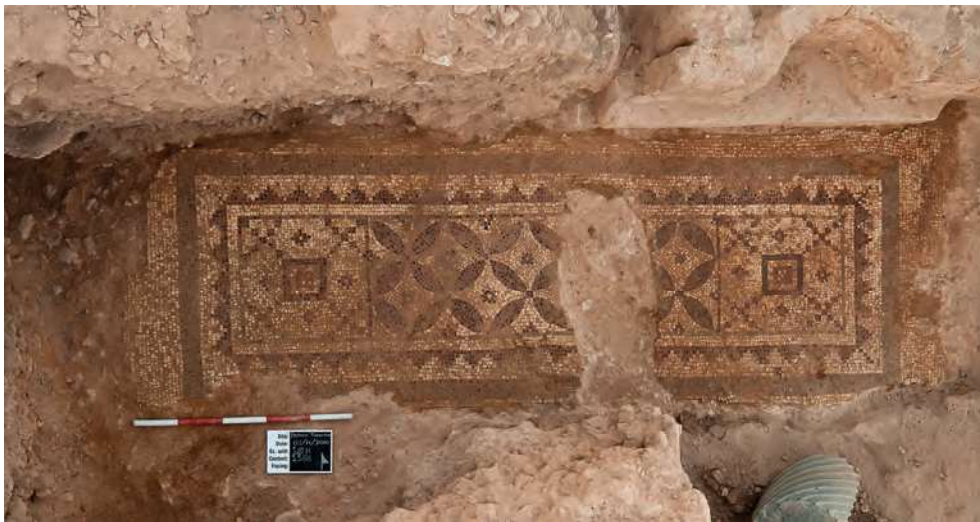
Fig. 4. The room to the south-west of the western *parodos* patterned with intersecting circles and octagons. The damage was caused by smashing columns for the lime kilns after the theatre had been abandoned and was used as a quarry (photo: Bob Miller, 10 November 2010)
